**Flood Control Project Maintenance
Levee Inspections**

Fall 2010 Levee Maintenance Deficiency Summary Report

Madera County FCWCA

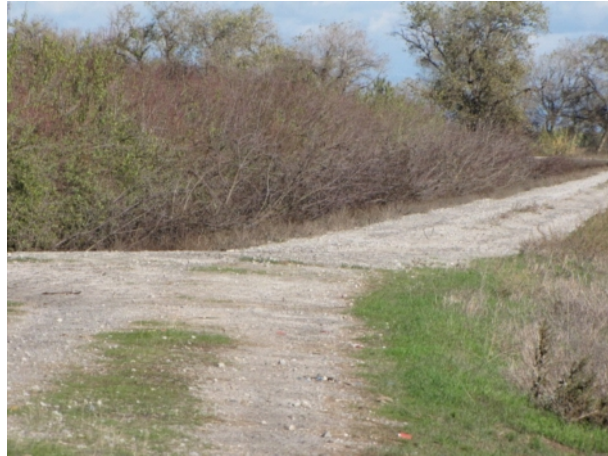
Levee Mile Report Line	2
Start Levee Mile	0.10
End Levee Mile	0.10
Location	Land Side
Category	Earthen Levee
Item	Vegetation
looking downstream from 0.10 veg. present on landside slope and toe of unit 1 Ash Slough. Photo taken 11-22-2010.	
phillips_f_20101124_313.jpg

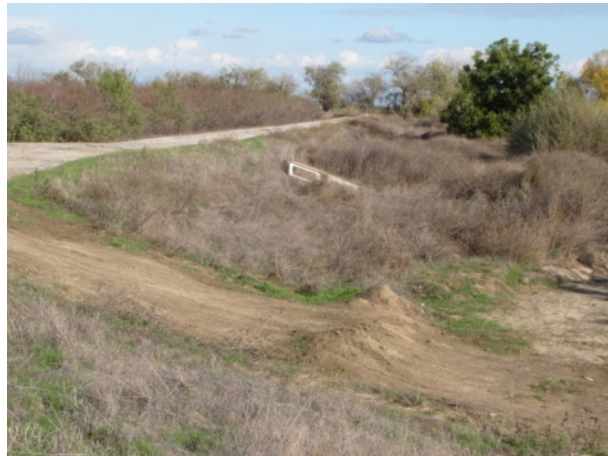
Levee Mile Report Line	3
Start Levee Mile	0.10
End Levee Mile	0.10
Location	Water Side
Category	Earthen Levee
Item	Vegetation
Looking downstream from levee mile 0.10 water side of Ash Slough dead weeds on slope. In far back ground is a abandoned camper shed. The District will frmove after the return from the Thanksgiving Holiday. Photo taken 11-22-2010	
phillips_f_20101124_314.jpg

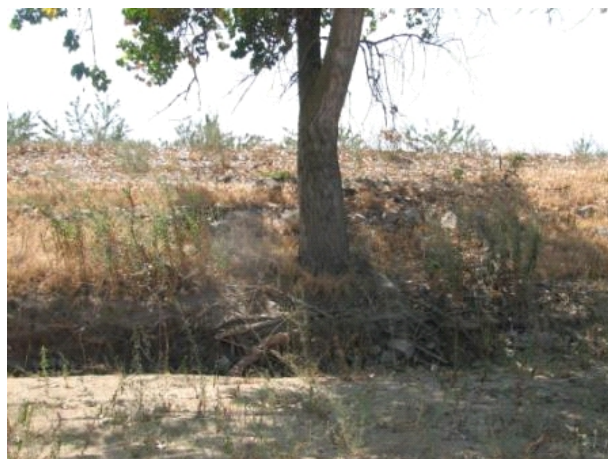
Levee Mile Report Line	8
Start Levee Mile	1.11
End Levee Mile	1.20
Location	Water Side
Category	Supplemental
Item	DWR Erosion Survey
Photo taken in 2007.	
SJR2010_RM2.57U1LM1.15RBa.jpg

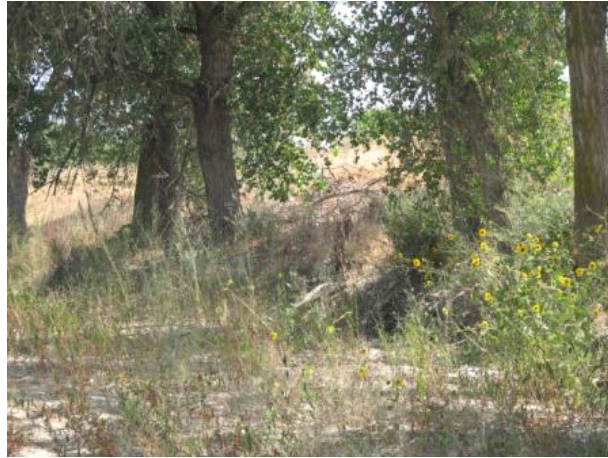
Levee Mile Report Line	8
Start Levee Mile	1.11
End Levee Mile	1.20
Location	Water Side
Category	Supplemental
Item	DWR Erosion Survey

Photo taken in 2007.

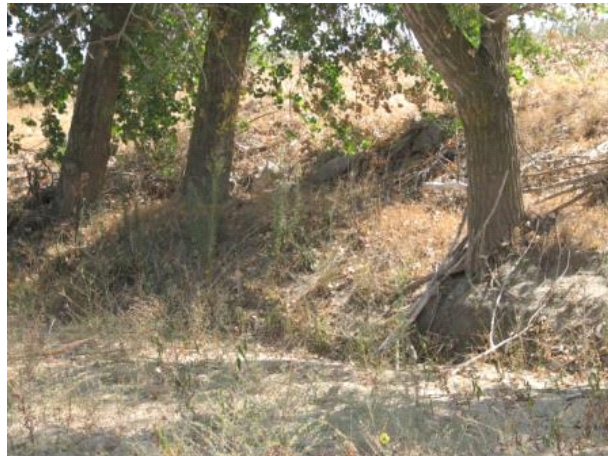
Levee Mile Report Line	8
Start Levee Mile	1.11
End Levee Mile	1.20
Location	Water Side
Category	Supplemental
Item	DWR Erosion Survey

Photo taken in 2007.

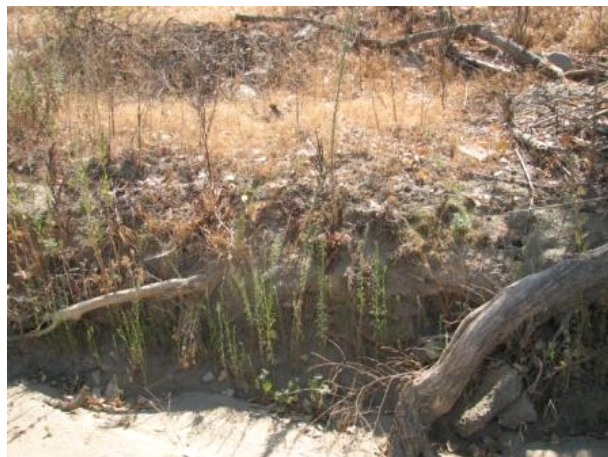
Levee Mile Report Line	8
Start Levee Mile	1.11
End Levee Mile	1.20
Location	Water Side
Category	Supplemental
Item	DWR Erosion Survey

Photo taken in 2007.

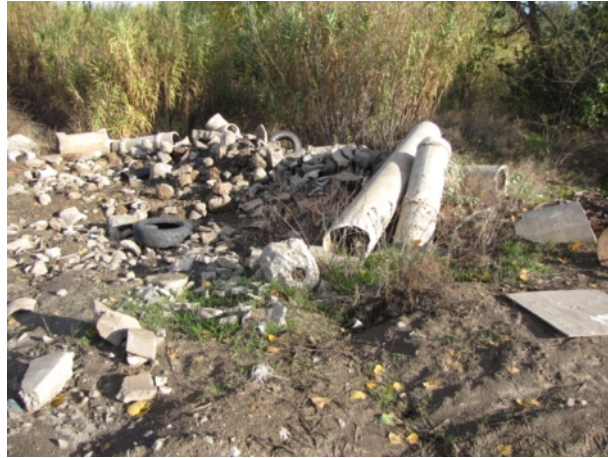
Levee Mile Report Line	10
Start Levee Mile	2.37
End Levee Mile	2.37
Location	Water Side
Category	Earthen Levee
Item	Encroachments

Pipe discarded along water side of Ash Slough and concrete rubble wastes on banks, during Spring inspection there were more materials, pipe, tires and concrete blocks. Most have been removed. All need to be removed from levee section. Photo taken 11-22-2010.

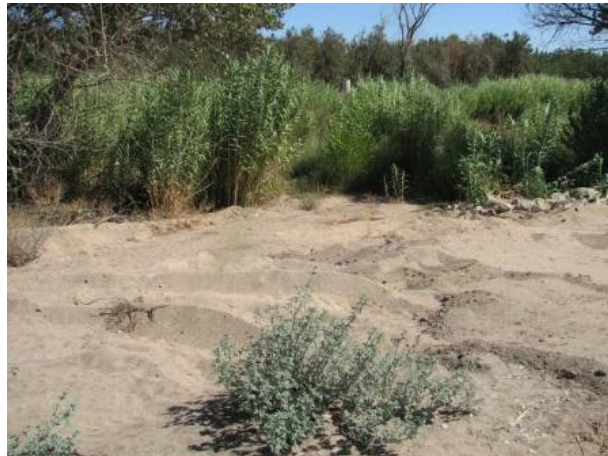
Levee Mile Report Line	11
Start Levee Mile	2.37
End Levee Mile	2.39
Location	Water Side
Category	Supplemental
Item	DWR Erosion Survey

Photo taken in in 2008.

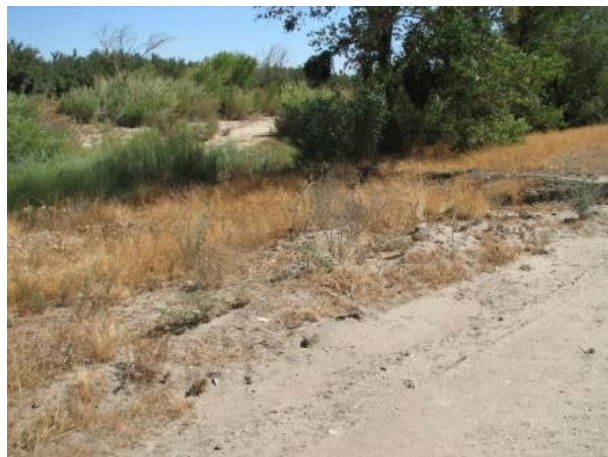
Levee Mile Report Line	11
Start Levee Mile	2.37
End Levee Mile	2.39
Location	Water Side
Category	Supplemental
Item	DWR Erosion Survey

Photo taken in 2008.

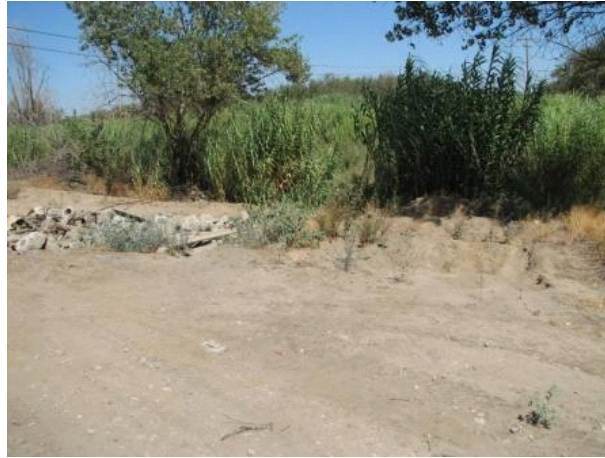
Levee Mile Report Line	11
Start Levee Mile	2.37
End Levee Mile	2.39
Location	Water Side
Category	Supplemental
Item	DWR Erosion Survey

Photo taken in 2008.

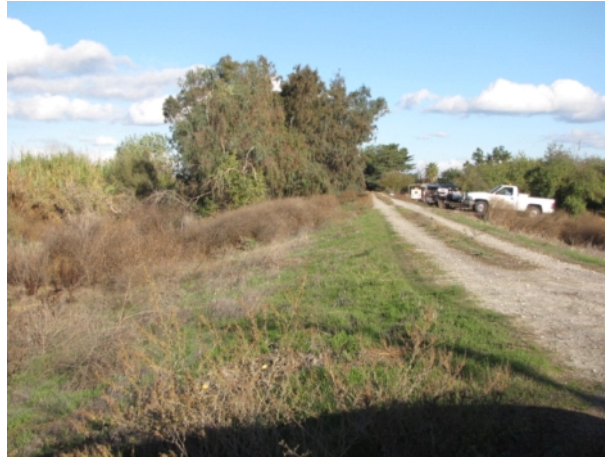
Levee Mile Report Line	1
Start Levee Mile	0.00
End Levee Mile	0.00
Location	Water Side
Category	Earthen Levee
Item	Vegetation

Looking down stream from levee mile 0.00 water side Unit 2 Left bank. Photo taken 11-22-2010

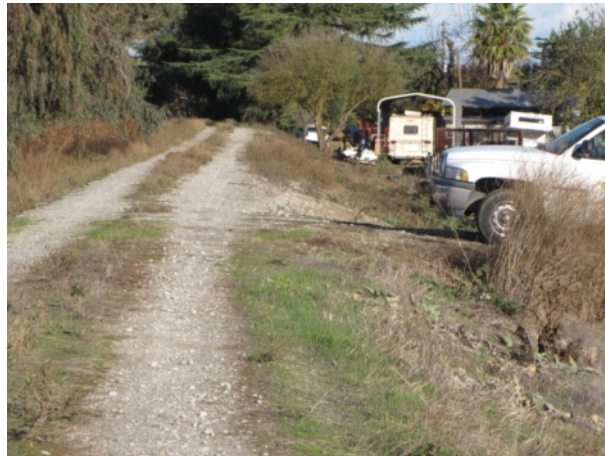
Levee Mile Report Line	2
Start Levee Mile	0.00
End Levee Mile	0.00
Location	Land Side
Category	Earthen Levee
Item	Vegetation

Looking downstream from levee mile 0.00 land side of Unit 2 Left bank. Photo taken 11-22-2010

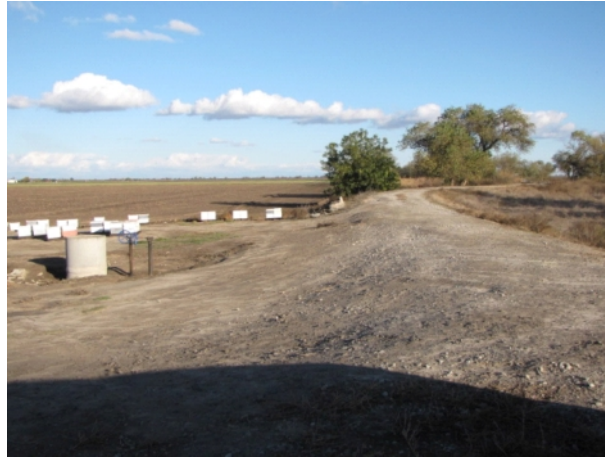
Levee Mile Report Line	1
Start Levee Mile	0.00
End Levee Mile	0.00
Location	Water Side
Category	Earthen Levee
Item	Vegetation

Looking down stream from 0.00 land side Right bank of Unit 3 Berenda Slough. Photo taken 11-22-2010

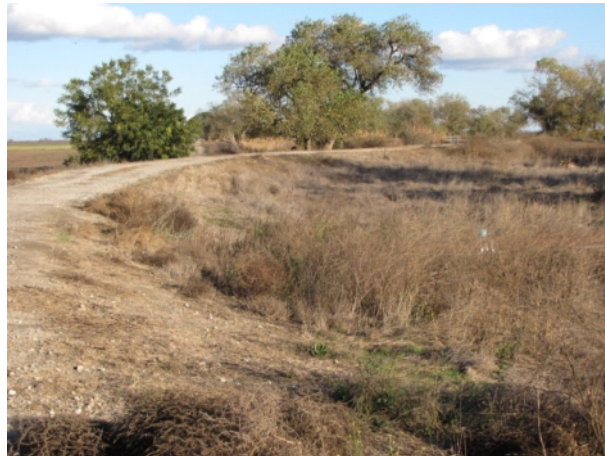
Levee Mile Report Line	2
Start Levee Mile	0.00
End Levee Mile	0.00
Location	Land Side
Category	Earthen Levee
Item	Vegetation

Looking down stream from levee mile 0.00 water side the brush appears to have been sprayed but not mowed. Photo taken 11-22-2010

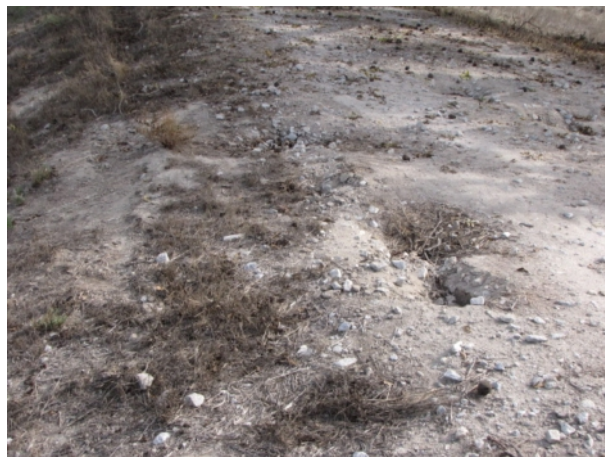
Levee Mile Report Line	12
Start Levee Mile	1.50
End Levee Mile	1.53
Location	Crown
Category	Earthen Levee
Item	Animal Control

There are several rodent holes in the shoulder and crown of the road way.

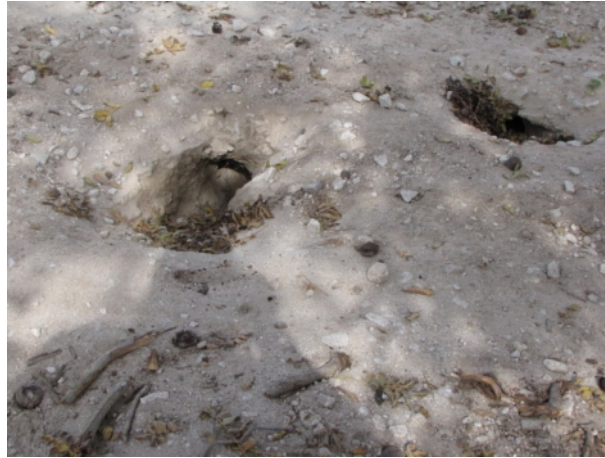
Levee Mile Report Line	12
Start Levee Mile	1.50
End Levee Mile	1.53
Location	Crown
Category	Earthen Levee
Item	Animal Control

This photo show holes in crown and shoulder.

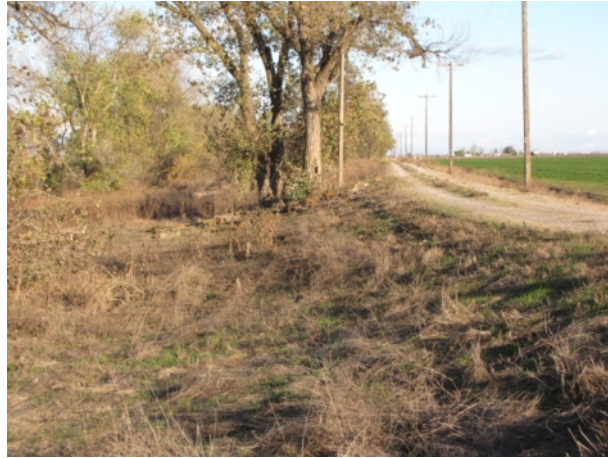
Levee Mile Report Line	1
Start Levee Mile	0.00
End Levee Mile	0.00
Location	Water Side
Category	Earthen Levee
Item	Vegetation
Looking downstream of Berenda Slough water side levee mile 0.00 at growth on slope. Photo taken 11-22-2010	
phillips_f_20101124_320.jpg

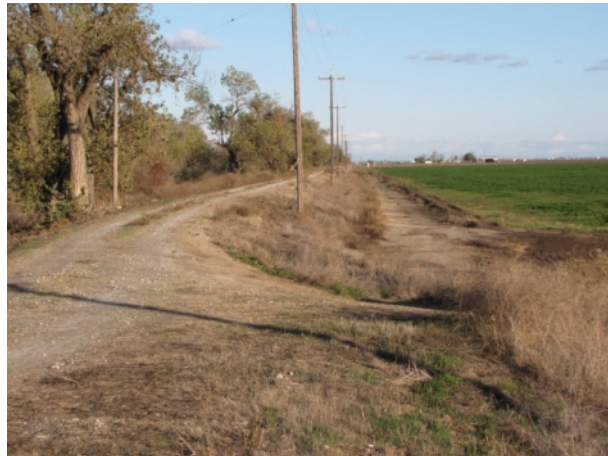
Levee Mile Report Line	2
Start Levee Mile	0.00
End Levee Mile	0.00
Location	Land Side
Category	Earthen Levee
Item	Vegetation
Looking downstream from levee mile 0.00 land ward Unit 4 Berenda Slough, slope has been mowed. Photo taken 11-22-2010	
phillips_f_20101124_321.jpg

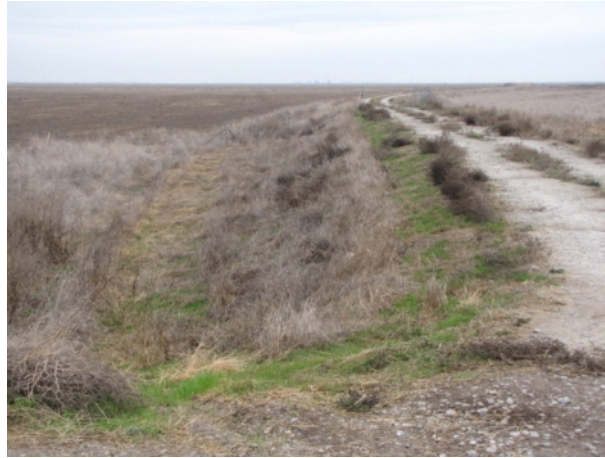
Looking downstream from levee mile 0.00 land side of Unit 5 Fresno River. Photo taken 11-24-2010

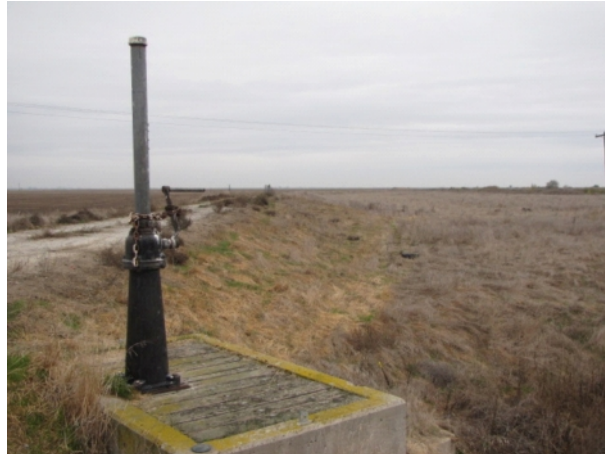
Levee Mile Report Line	1
Start Levee Mile	0.00
End Levee Mile	0.00
Location	Land Side
Category	Earthen Levee
Item	Vegetation

Looking down from levee mile 0.00 water side Unit 5 Fresno River. Photo taken 11-24-2010

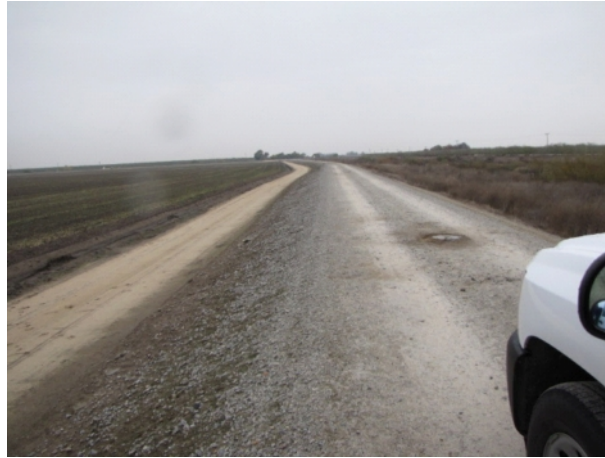
Looking downstream from levee mile 2.50, the Property owner keeps this section free of vegetation to levee mile 6.06 land side and water side. Photo taken 11-24-2010.

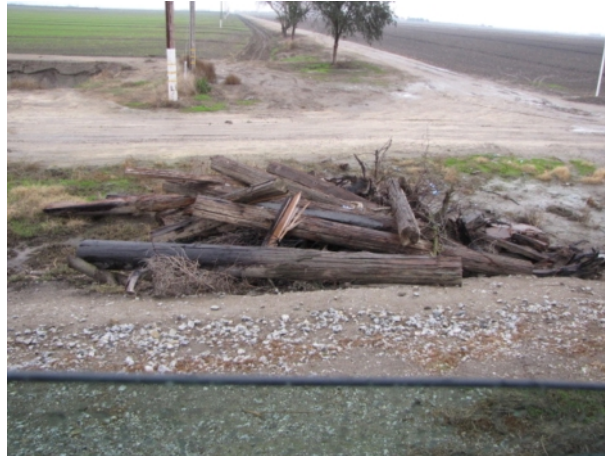
Levee mile 5.72 discarded power poles on landside toe need to be removed from levee section. Photo taken 11-23-2010

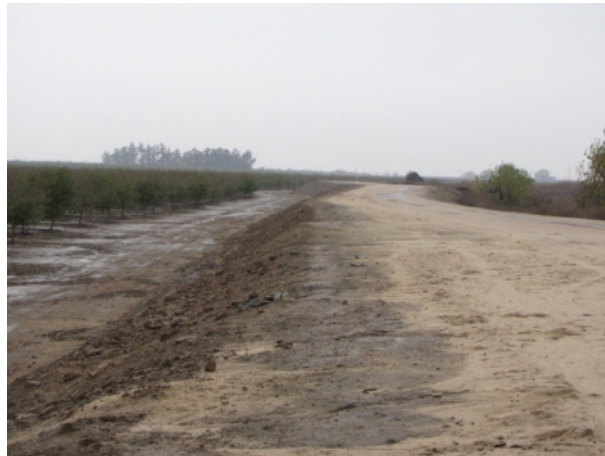
Levee Mile Report Line	10
Start Levee Mile	9.14
End Levee Mile	9.14
Location	Land Side
Category	Earthen Levee
Item	Vegetation

Standing at levee mile 9.14 looking back upstream of Unit 6 Fresno River land side shoulder. Photo taken 11-23-2010 Working in reverse from downstream 9.14 to 0.00 upstream.

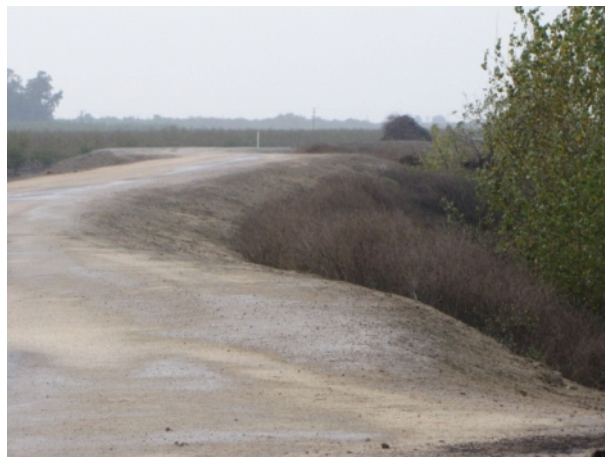
Levee Mile Report Line	10
Start Levee Mile	9.14
End Levee Mile	9.14
Location	Land Side
Category	Earthen Levee
Item	Vegetation

Standing at levee mile 9.14 water looking upstream of Unit 6 of Fresno River. Photo taken 11-23-2010
